# Manhole Inspection Summary

Manhole # S33GG1027MH

Insp Date: **2/1/07 3:39 PM**

**Location** Address: **1 WENDOVER RD**

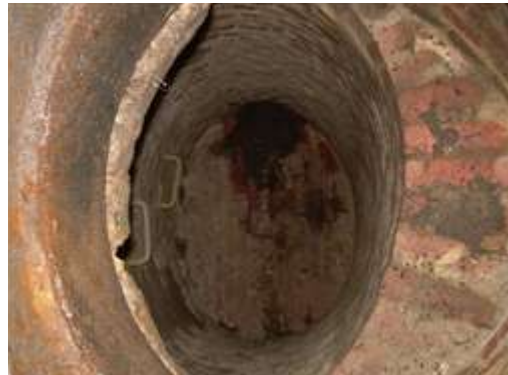
Top View

Channel debris.

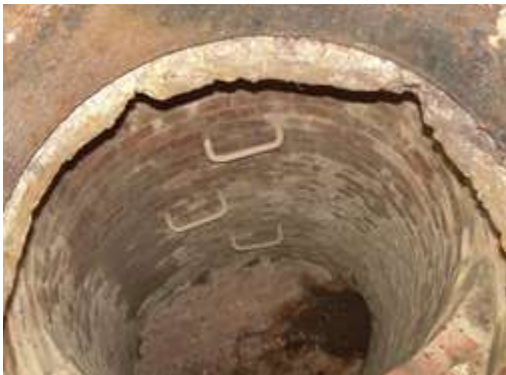
Defect

Frame leaks. Adjustment deterioration and infiltration. Corbel infiltration.

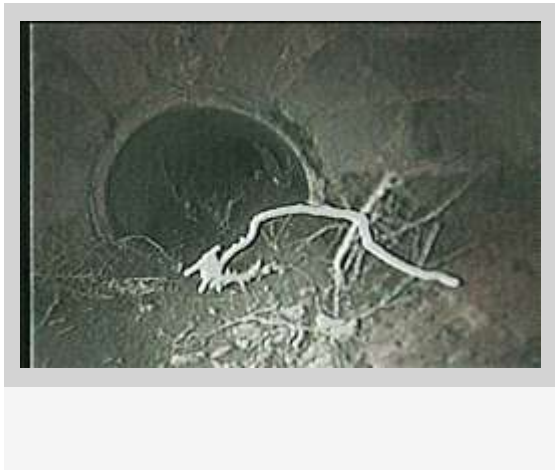
8 in. Circular Gravity Sewer  
Pipe Out @ 12 O'Clock

Deposits: ☐ None ☒ **Mud** ☐ Sludge ☒ **Debris** ☐ Grease

Silt Depth: **2** (in.) Deposits Extent: **Light**

Infiltration: **Evidence** Pipe Seal Cond: **Cracked**
